Mariners' Alerting and Reporting Scheme

MARS Report No 345 July 2021

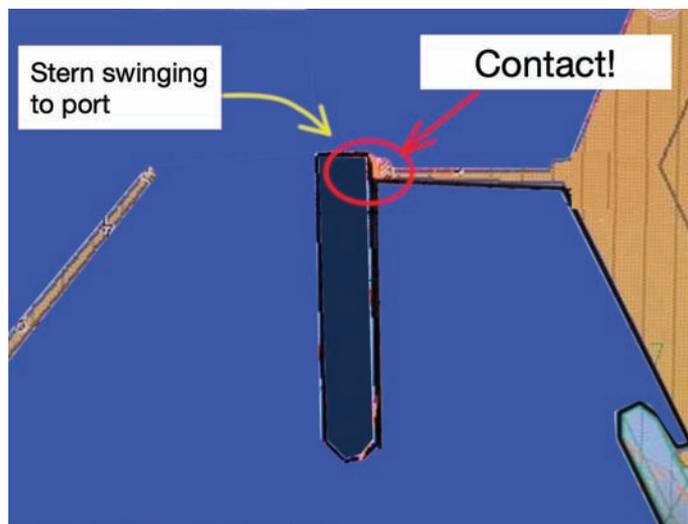
→ A vessel was proceeding from anchorage to berth under pilotage. Two tugs were providing assistance; one was made fast aft and the other used for pushing where needed. The pilot was communicating with the tugs in the local language, which the Master did not speak. As the vessel proceeded, a second (docking) pilot boarded the vessel and quickly took over from the first pilot. The change of pilot happened at a critical stage while the vessel was turning in a basin prior to entering the breakwater.

Because of this developing situation, it was not possible to carry out a Master/pilot information exchange with the second pilot. When the vessel's bow entered the basin and the forward tug was pushing the bow to starboard, the Master realised that the vessel's stern was not going to clear the breakwater. He immediately ordered engines full ahead and helm hard to port, but these actions were too late to avoid contact on the vessel's port quarter.

Since this breakwater was without fenders, the vessel suffered some minor hull damage on contact. The company investigation found that, among other things, the change of pilots at a critical stage of the manoeuvre did not allow the docking pilot enough time to become accustomed to the prevailing conditions, position, speed, rate of turn, and position/status of the tugs.

The company investigation also found that the tug orders were given by the pilots in a language other than English. This had the effect of excluding the Master, making him less aware of the developing situation. Due to this communication gap, the Master could not effectively use tugs to control the vessel's swing.

- Occasionally, the fact that tug orders are given in a local language and are not understood by the bridge team has contributed to a bad outcome. Until this unsafe condition is addressed, these accidents will continue to occur.

- In this case, the company decided to reinforce their navigational audits for compliance with docking procedures by using remote VDR audits and onboard navigational audits by independent third-party auditors.

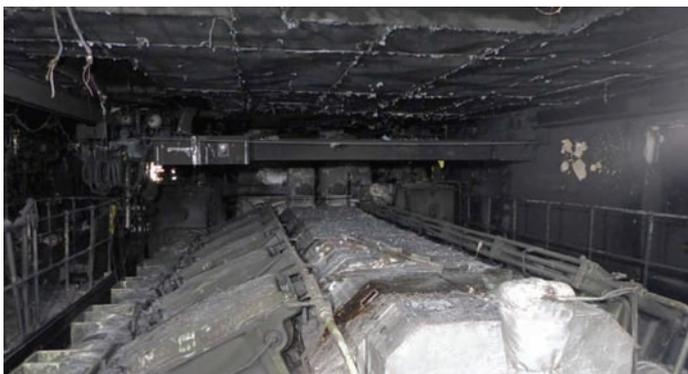
→ A ro-ro cargo vessel was underway. At about 20.00, the engineer of the watch (EOW) left the engine control room (ECR) and started his hourly rounds of the engine room and machinery spaces. Shortly after entering the purifier room, he heard loud metallic knocking sounds coming from the engine room. Meanwhile, vibrations were being felt on the bridge by the OOW. He immediately reduced the controllable-pitch propeller (CPP) from 60% to 25%. He then saw that the fuel consumption meter was also fluctuating and giving abnormal readings, while various engine warning lights were illuminated.

The EOW opened the purifier room door, looked out into the engine room and saw smoke rising from the port forward end of the main engine. The noise and vibration levels rapidly increased and, sensing danger, he ran back into the purifier room and crouched behind one of the purifiers. Almost immediately there was a loud bang and flames flashed past the open purifier room door; the space quickly filled with thick black smoke. The ship blacked out, but within seconds the emergency generator started and the emergency lighting came on. Despite this, the smoke in the engine room had reduced visibility to almost zero.

- The fire was the consequence of a sudden major engine component failure, which led to the ejection of heavy engine parts from the crankcase and release of hot oil vapours into the engine room.
- Although the crew were confident the CO₂ had been released, there was no information in the bottle room to identify easily which spaces were protected by which CO₂ bottles. There were no visible means of identifying whether the gas bottle operating valves were open or closed.
- The accident demonstrates that more consideration could have been given to the number and location of EEBDs in this vessel's engine room even though the required number had been fitted. For example, an additional EEBD at the secondary escape ladder on the tween deck level would be a sensible addition.

- Every fixed gas fire-extinguishing system control station should have clear instructions for the operation of the system and means to identify which bottles have been spent.
- EEBDs are not an onerous expense. Proper consideration should be given to fitting all escape routes on vessels with EEBDs, even at the cost of going over the number of EEBDs required by class.

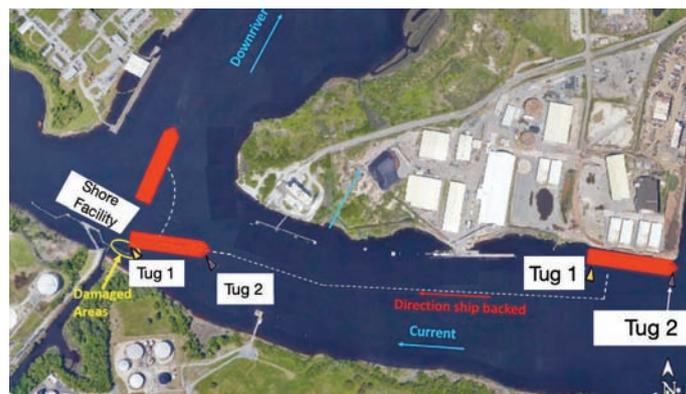
As the manoeuvre progressed, the backing speed increased to about 2.9 knots. The aft tug (tug 1 in the diagram) was pushing at full power in an attempt to push the vessel's stern north, away from the shore facility. As the bulk carrier and tug approached the shore facility astern, the pilot requested that tug 1 stop pushing and that it be brought close by the bulk carrier. The tugmaster complied. By now the astern speed had reached 3.2 knots and the vessels were backing quickly into a shore facility. The pilot made several ahead engine orders to try to save the

situation in addition to hard starboard rudder. These actions did not prevent the bulk carrier from squeezing the tug on to the shore facility, striking a concrete pile for a mooring dolphin and then a walkway. Although damage to the tug was minimal, the shore facility suffered about \$1.47 million damage.

It transpired that conventionally powered tugs were not normally used for this manoeuvre. Instead, the norm was to use more efficient tugs with 360-degree azimuth power.

The official investigation found, among other things, that the speed at which the assisted vessel was being backed was too high for conventionally powered tugs to be used in an effective manner, resulting in contact with the shore facility. Another contributing factor was the less than adequate communication between the docking pilot and the bulk carrier's Master and also the tugmasters.

- Communication is key: everyone involved should have the same understanding of the manoeuvre.
- When undertaking familiar tasks with unaccustomed equipment it may be wise to step back and re-evaluate the risks and procedures.
