Mariners' Alerting and Reporting Scheme

MARS Report No 344 June 2021

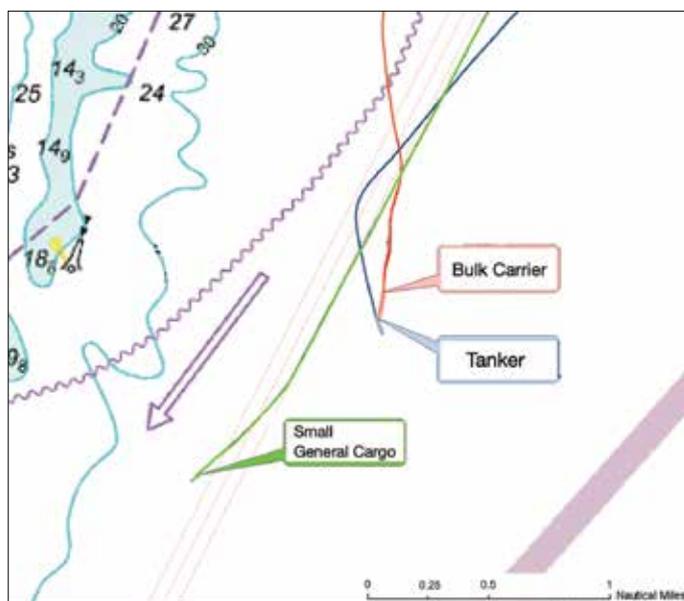
The vessels were now too close and a near parallel collision was inevitable. The general alarm was sounded on both vessels. After contact, the vessels remained immobile alongside each other for about an hour. Then, the tanker manoeuvred away. Neither vessel required assistance to make for a port of refuge.

The official investigation found, among other things, that the tanker Master's reaction times and decision-making ability were possibly reduced, as indicated by his omission to check for sea room before the port course alteration. The contributing factors that lead to this reduced ability were the time of day and possible fatigue of the Master. This was his first transit of this high traffic area, so mental loading may also have played a role.

- The person with the con of a vessel should listen intently to any critical communication with other vessels, even if this task has been delegated to another bridge team member.
- Long-range scanning of vessel movements via radar is preferable to last minute VHF communication for collision avoidance.

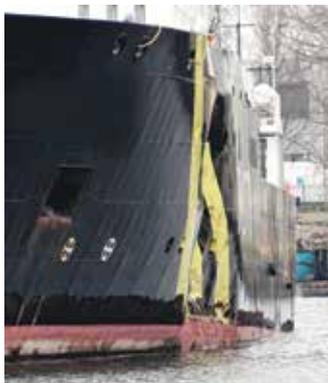
At this time the mother ship continued on autopilot. The captain was still preoccupied with administrative tasks. At 04.12, the mother ship collided with the starboard bow of the bulk carrier. Several crew members suffered minor injuries; there were no injuries aboard the bulk carrier.

Damaged PSMS

- As mentioned in many past MARS lessons learned, darkness changes everything! It is hard to imagine this accident happening in daylight and good visibility. When in darkness, re-double your attention.
- As also mentioned in many past MARS lessons learned, being preoccupied with other tasks instead of navigating your vessel changes everything. Put distractions and other tasks away when navigating your ship.
- Making assumptions about the movements of other vessels, even in apparently clear-cut circumstances, can have negative consequences. In this case, the bulk carrier’s crew and pilot assumed the PSMS would stay clear, but at no time did they confirm this with the PSMS via VHF communication.

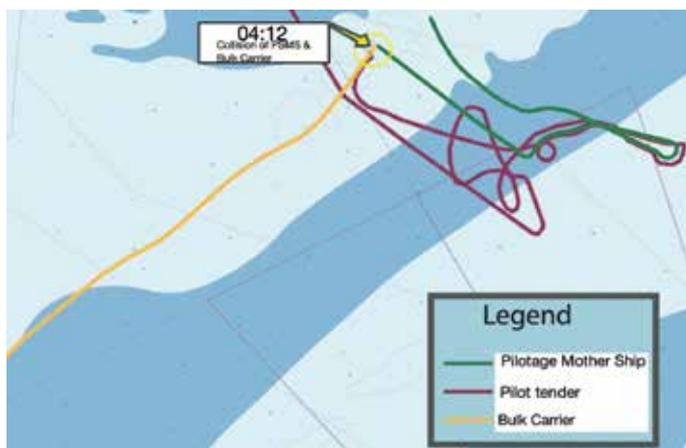
The official investigation mentioned that both the pilot and the crew of the bulk carrier assumed that the mother ship was involved in the pilotage operation. They therefore assumed, somewhat justifiably, that it would not hinder their movements.

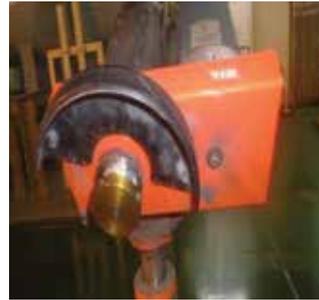
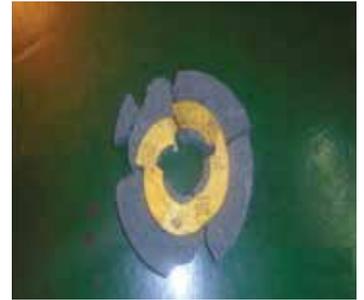
→ An electrician was assigned to repair an electrical deficiency in the grinder used for main engine exhaust valve maintenance. Following the repairs, the grinding stone shattered during final checks and testing. One of the pieces hit the electrician's forehead.

The company investigation revealed that the electrician had worn a safety helmet but it had not been secured with the strap. The flying projectiles had hit the helmet and dislodged it, allowing injury. A face shield had not been worn either.

- Grinders turn at high speed and even if they have their own built-in shields, crew should always wear face protection when using them.
- Grinding wheels and discs can shatter – be aware of this and use PPE appropriately.
